DEDICATED SOLUTIONS FOR STRUCTURAL HEALTH MONITORING OF AIRCRAFT COMPONENTS

Dissertation presented
in partial fulfillment of
the requirements for
the Degree of Doctor
in Engineering Sciences

June 2015

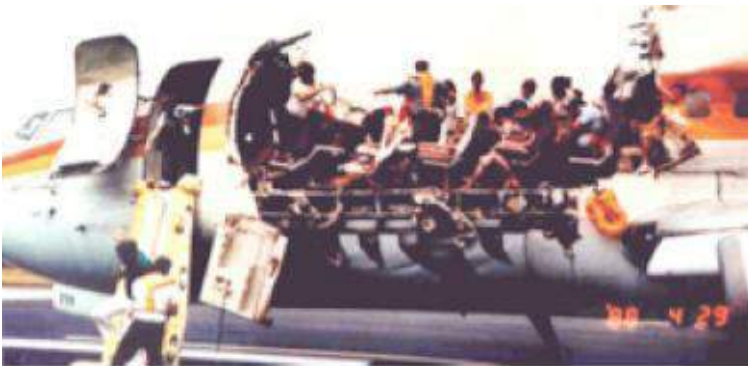
Figure 2.2: Photo of an extended structural failure to a Boeing B737-297 aircraft of Aloha airlines due to fatigue [21].

Investigations revealed that the fuselage suffered from “maritime corrosion” affecting rivets and lap joints connecting the fuselage to the other parts of the structure. According to the National Transportation Safety Board (NTSB) there were indications of pre-existing cracks that accelerated the process of fatigue fracture [22]. NTSB reported that the aircraft had accumulated 35496 flight hours and 89680 flight cycles.

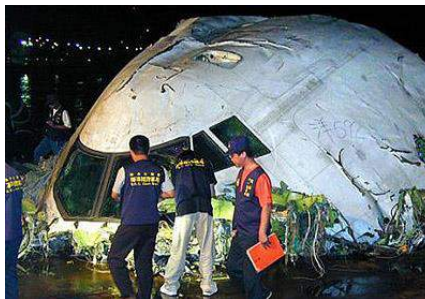
Figure 2.4: The wreckage of the front part of the Boeing B747-209B aircraft from the accident of China airlines flight 611 [25].

Due to fatigue, the pre-existing cracks were steadily growing together with additional cracks initiating from the rivets. Poor maintenance of the aircraft had a consequence of the fracture of the metallic parts of the frame that finally the accident caused the death of all 206 passengers and 19 crew members.

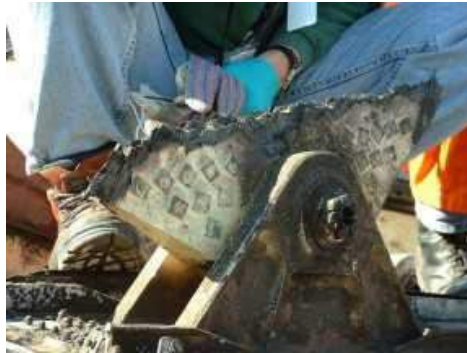
Figure 2.5: Close up photo of the attachment point of the vertical stabilizer of Airbus A300 from American Airlines flight 587 directly on the crash site [26].

The reason of the accident was the delamination on the composite lugs that are used to attach the vertical stabilizer. The delaminations were a result of previous heavy turbulences and the poor maintenance of the aircraft did not consider the delamination problem. It was also found that the design of the composite lugs was not strong enough to withstand the high stresses that stretching the parts above their limits.

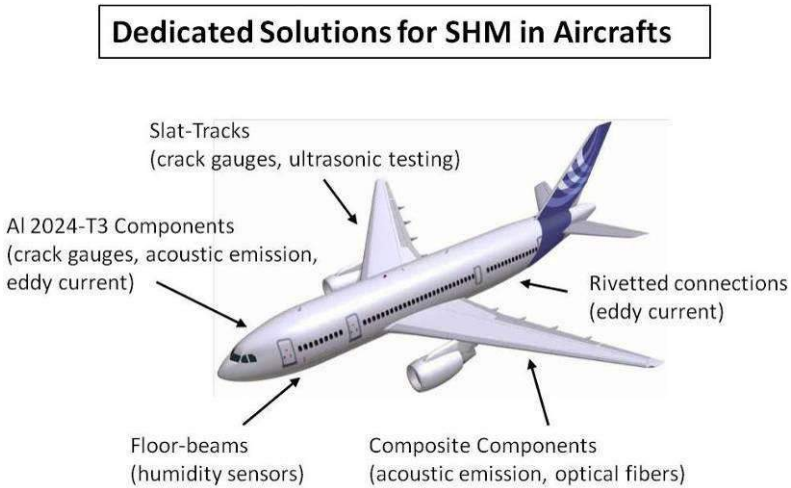
Figure 4.9: SHM solutions used in this study on critical areas of an Airbus A320 aircraft [9].

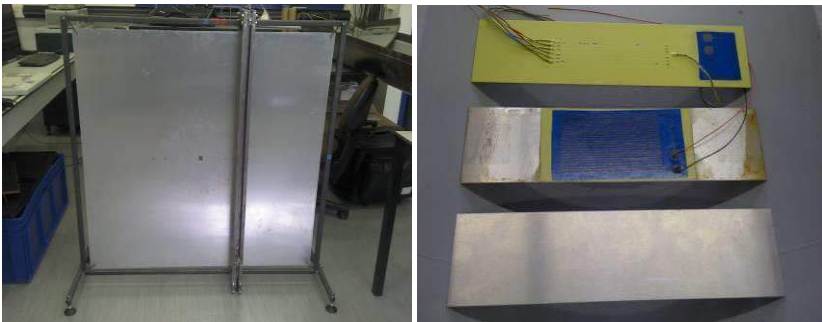
Figure 4.10: Al plate (left) for ultrasonic testing and Al 2024-T3 plates (right) for fatigue testing using various NDT methods.

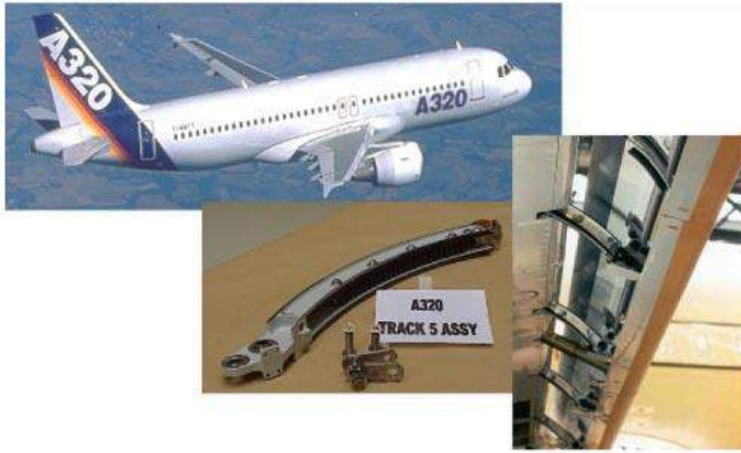
Figure 4.11: Airbus A320 Slat-Track selected for NDT purposes [127].

An Airbus A320 slat-track manufactured by ASCO Industries was used for testing purposes. Slat-tracks are the components that confine and roll the slats on them during their operation. The slats are extensions that are used to increase the surface area of the wings during take-off and landing [126]. The slat-tracks expand the slats and transfer the stress between the slats and the wings of the aircraft. They are made of maraging steel as they need to be very strong and tough since they have to withstand a very high amount of stress [176].

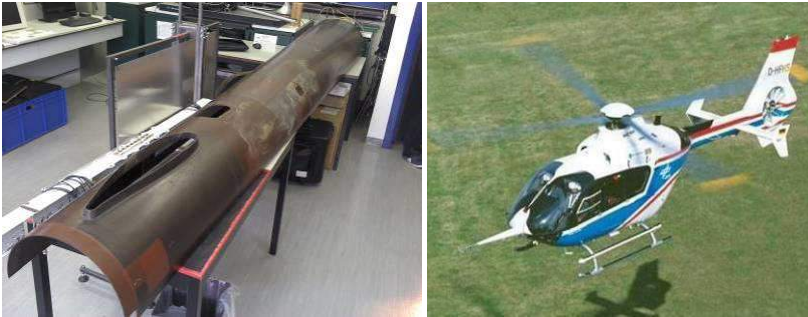
Figure 4.13: Full scale honeycomb composite tail boom (left) from an Eurocopter EC135 helicopter (right) [128].

A tail boom from a Eurocopter EC 135 helicopter was used to investigate instant impact and impact damage together with delamination problems. The tail boom is about 4 meters in length and is made of honeycomb composite material. Piezoelectric transducers, a sonotrode and optical fibres have been attached in the inner side of the tail boom for NDT purposes. The full scale part had two rows of

single mode optical fibres protected in SMARTape and 32 piezoelectric transducers. The smaller part had also two smaller rows of SMARTape and 4 patches of PZT.

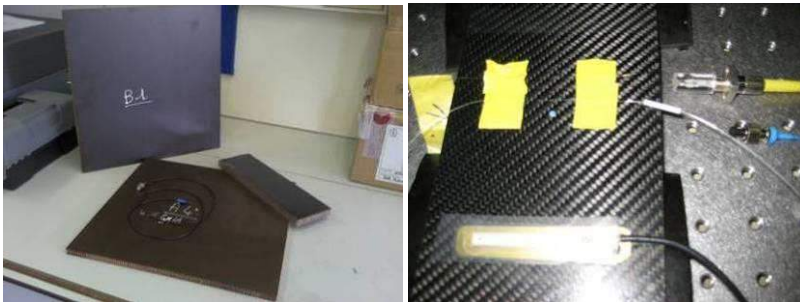
Figure 4.14: Composite plates used for NDT purposes at the KU Leuven.

Square shaped honeycomb composite plates of sizes of 400 x 400 x 13 mm (length x width x thickness) as well as Carbon Fibre Reinforced Epoxy (CFRE) plates of smaller dimensions were used for ultrasonic testing and acoustic emission investigations. Piezoelectric transducers as well as single mode and multi-mode optical fibres were used for impact damage detection.

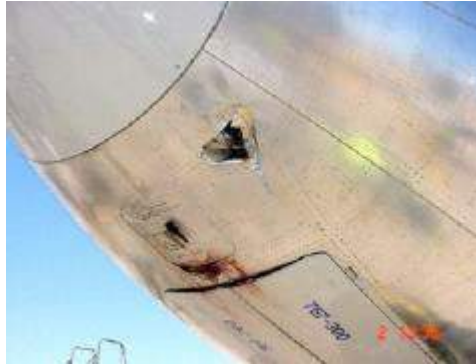
Figure 4.21: Photo of bird strike damage on the fuselage of a Boeing B767 aircraft [21].

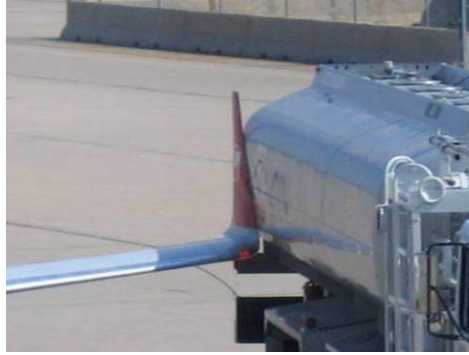
Figure 4.22: Photo of an aircraft's wing collision with a fuel tanker [151].

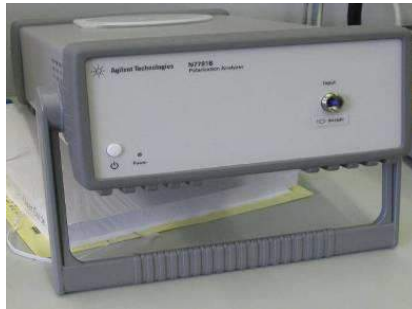
Figure 4.25: AGILENT high speed polarization analyzer/controller (N7788B-400).

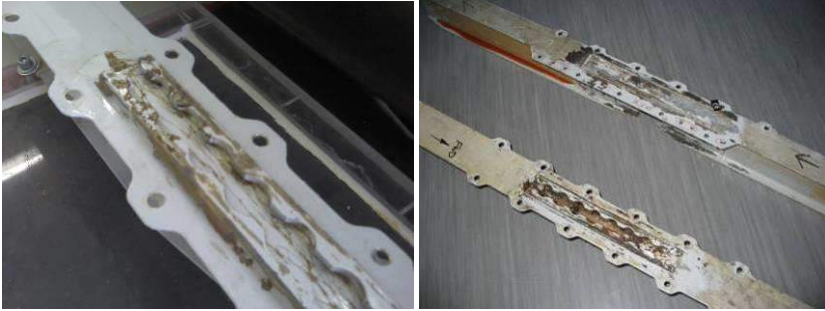
Figure 4.26: Corrosion on seat tracks attached on floor beams from the cabin of an Airbus A320 aircraft.

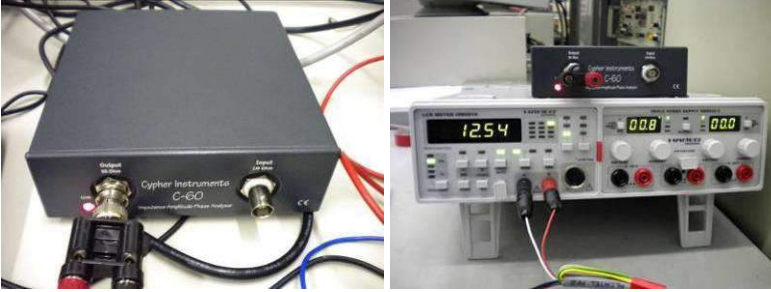
Figure 5.6: Cypher C-60 (left) for phase and impedance and the LCR HM8018 (right) for inductance acquisition.

Electromagnetic impedance spectroscopy is used to collect the data. From the Cypher Instruments C-60, see figure 5.6, the electromagnetic frequency chosen for further analysis is 15 kHz. The analysis for electromagnetic frequencies of 5 kHz and 10 kHz provided the same general information.

Figure 5.6 shows both instruments used to measure and record the phase, impedance and inductance of the coil sensor during the fatigue experiment. The Cypher C-60 is an Impedance-Amplitude-Phase Analyser from Cypher Instruments Ltd, and it was used for the phase and impedance acquisition. The LCR Meter HM8018 from HAMEG Instruments GmbH was used for the inductance acquisition.

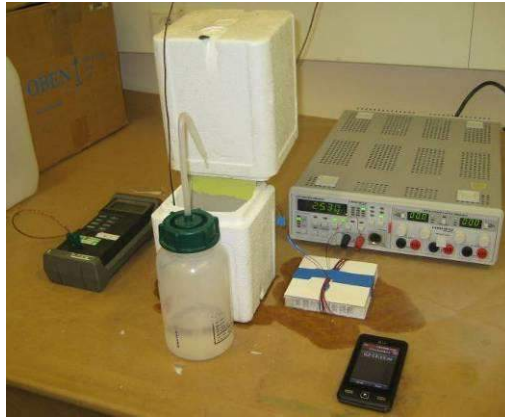
Figure 5.12: Cooling system for the Al 2024-T3 plate using dry ice and methanol.

From -50°C to room conditions ($\sim 22^{\circ}\text{C}$), the temperature was controlled by adding methanol, as it accelerates the temperature rise, and it was monitored by a thermocouple. The impedance measurements were obtained using the LCR HM8018 multimeter. The setup can be seen in the figure below.

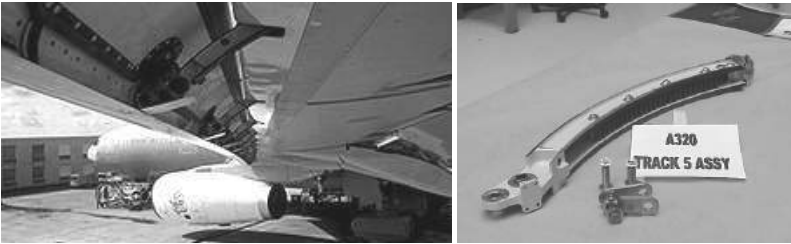
Figure 6.3: Slat-track (Left side: position in airplane wing – Right side: dismantled) [176].

The A320 slat-track has a length of 64 cm and is made of maraging steel (grade 250) as it needs to be very strong to withstand the very high loads during take-off, landing and flight. The slat is the component of the aircraft located at the front edge of the wing and it is mounted on curved tracks, see figure 6.3. The whole mechanism is called a slat-track and its function is to keep the airplane from stalling when it is flying at high angles of attack [178].

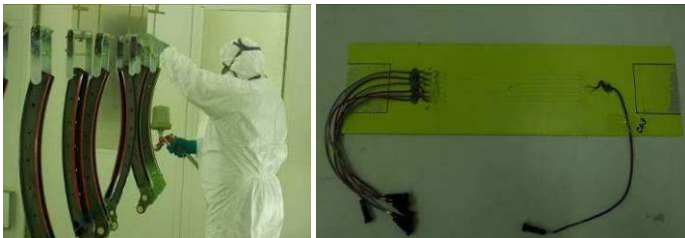
Many metallic aircraft components are coated by primers and finishing coatings. The same procedure was followed for the aluminium 2024-T3 plate and the Airbus A320 slat-track, see figure 6.4. The surface of the component was first coated with a layer of epoxy primer, usually of yellow or green colour, in order to insulate from electrical conductivity and maximize protection against corrosion. After the epoxy primer, a top coating made of polyurethane was applied on the component from the outside surface. It gives the decorative final colour for the product, and it provides chemical, stain and UV resistance. The painting procedure of the Airbus A320 slat-track was completed at the manufacturer of this component; ASCO Industries N.V., Zaventem, Belgium.

Figure 6.4: Painting procedure (Left side: Slat-tracks – Right side: finished Al 2024-T3 plate).

For the tests of this study, the A320 slat-track was painted with primer and the top-coating and the aluminium 2024-T3 plates were coated only with the epoxy primer.

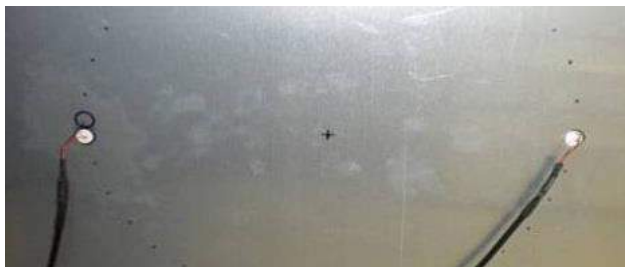
while it is in the liquid phase. After seconds it cools down and creates a small solid layer on the sensor. Then, the sensor is attached on the aluminium plate by holding it at the point of preference and at the same time the aluminium plate is heated on the other side using a steamer. The heat melts the layer of paraffin and the attachment on the plate is successful. To remove the sensor, the plate is heated using the steamer at the point where the sensor is attached and then the process is repeated 10 times for reliability purposes. Table 8.2 below shows the root mean square (RMS) values of the amplitude of the acoustic response in millivolts. The test showed that the acoustic deviation was less than 10% which was within the reasonable limits. Figure 8.9 shows the sender and receiver positioned opposite each other.

Figure 8.9: Sensors attached on the aluminium plate by paraffin in a set-up to test the reproducibility. The left PZT is used as an excitation source on the aluminium plate and the excited signal is coming from the waveform generator at 350 kHz with 5 bursts at 10 V_{pp}

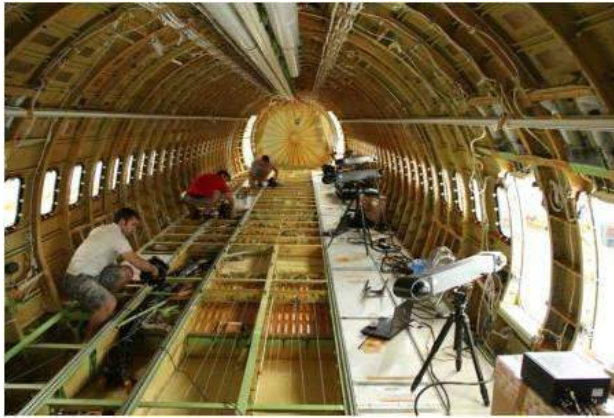
Figure 9.1: Floor beams inside an Airbus A320 after removal of the floor panels (photo courtesy of Lufthansa).

Due to their complex design, confined parts can frequently be found in aircraft structures and such spaces are more difficult to monitor because of the restricted access. Moreover, they are also not always designed to host workers for maintenance purposes [207]. Examples of such parts are the beams that are located below the floor of the cabin of an aircraft. They run across the aircraft along its length and support the floor composite plate of the cabin. Airlines have a scheduled maintenance program but usually the time interval between these maintenances is very long (4-6 years) so that the corrosion can usually not be detected in an early stage.

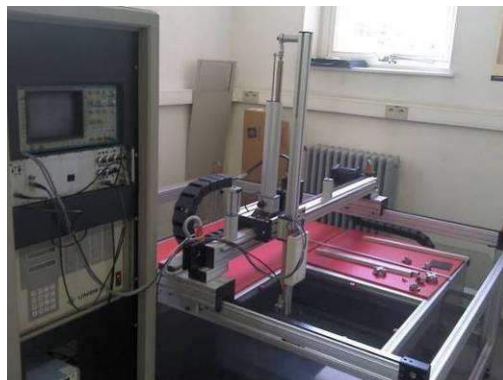
High frequency ultrasonic top view C-Scans were performed by a C-Scan equipment available in the NDT laboratory of KU Leuven. This NDT technique examines defects, porosities and strong differences in acoustic impedance inside the material and permits their identification. The figure below shows the C-Scan robotized instrument that is used for the experiments.

Figure A.5: Ultrasonic C-Scan equipment in NDT laboratory, MTM, KU Leuven.

The C-Scan consists of a very high frequency (up to 50 MHz) pulse-echo ultrasonic microscope that is positioned above the component under investigation. A transducer is scanning the component at a pre-defined speed and the computer generates the scanned images at the screen. The coupling medium can be water or air and in our case, the transducer is positioned slightly under the surface of the water which is used as a couplant. The transducer has both the role of a generator of the pulses and receiver of the echo. Depending on the discontinuities inside the material under investigation, the return times of the echo to the transducer is changing. By knowing the distance of the transducer from the component as well as the thickness of the component, the return times can give an estimation of the size of the defect together with its location in depth [218]. The computer is synchronized with the transducer and the peak amplitudes of the returning signal are stored in the computer database. From this database the computer generates an echo pattern of the scanned area. The echo pattern that is displayed on the screen is known as the A-Scan.

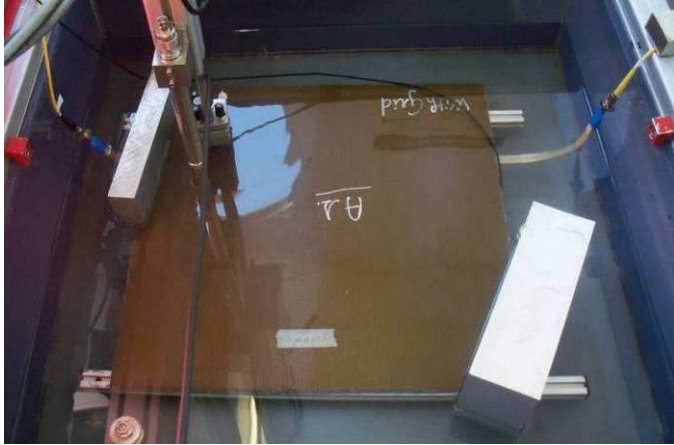
Figure A.6: A honeycomb composite plate submerged into water and monitored for structural flaws using a C-Scan equipment.

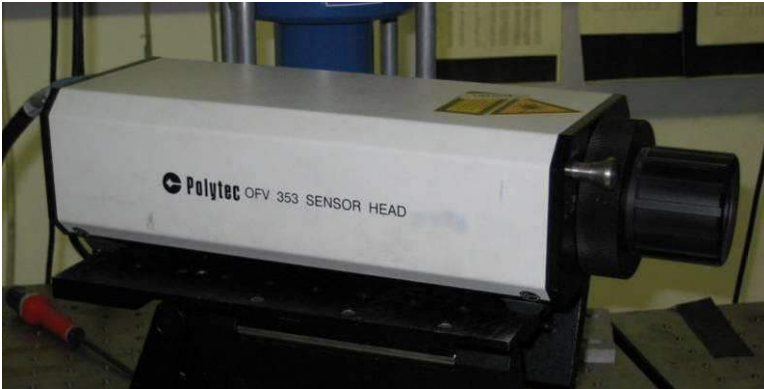
A Laser Doppler Vibrometer (LDV) is an optical instrument that its operation is based on the Doppler Effect. It uses a laser beam that continuously measures frequency changes due to vibrations on the reflecting surfaces [231]. The LDV was a Polytec OFV 353 as can be seen from the figure below. The LDV was equipped with a Polytec OFV 3001 vibrometer controller.

Figure A.13: A Polytec OFV 353 Laser Doppler vibrometer.

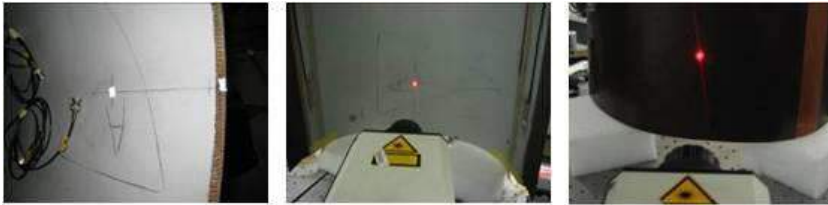
Figure A.14: Laser Doppler vibrometer monitoring structural flaws on the surface and in the core of an EC 135 tail boom.

Figure A.14 above shows target points of the laser beam. The laser beam can be seen with the red dot on the part of the EC 135 tail boom. In order to have a light reflection to the LDV exactly at the same direction, a small piece of retro-reflective tape was used on the target point, see figure A.14, left image. The signal generator used was an Agilent 332550A, the oscilloscope for the signal plotting was a Hewlett-Packard Infinium 500 MHz and the signal amplifier was from HQ Power Professional Audio. A rectangular PZT with 5 cm in length and 1 cm width that was obtained from PIEZOCERAM, S.R.O., Czech Republic, served as an excitation source for Lamb waves.

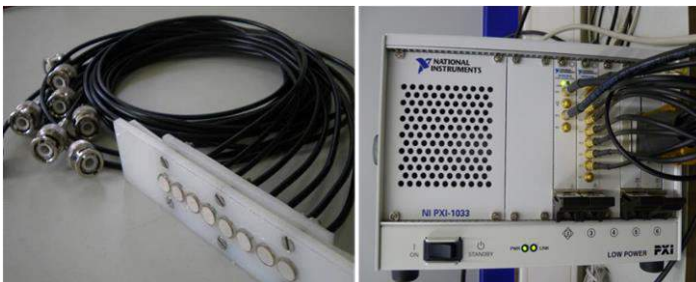
An array of sensors for flaw detection has a higher potential than point sensors standing alone. Having many sensors working together can result to more accurate measurements for the localization of the possible damage. In this study, an eight channel air-coupled array transducer has been tested and investigated on a composite honeycomb plate as well as on a composite part from the tail boom of the Eurocopter EC 135 helicopter. The air-coupled ultrasonic technique is combined with Lamb wave excitation from an actuator. The goal is to visualize how the Lamb waves interact with the defect and read the incoming acoustic signal from receivers that are placed in different locations. In that way, not only the existence of the defect can be monitored but with further analysis of the incoming signals, it is possible to predict the possible location of the defect on the sample under investigation. In this study the air-coupled array that is used for the test purposes is equipped with eight electrets microphones at distance of 15mm from each other. The electrets microphones are generating electric field in the air gap [237]. The array was positioned in different locations and the arriving signal was analyzed. The array was connected to a National Instruments NI PXI-1033 data analyzer, see figure A.19.

Figure A.19: An array of air-coupled electrets microphones used for defect detection on composite plates (left), NI PXI-1033 analyzer (right).

On the composite samples under investigation, a piezoelectric transducer ($d = 7\text{mm}$) has been attached in order to act as a source of wave excitation. The air-coupled array transducer receives the acoustic signals from the source and the data are collected from the National Instruments NI PXI-1033 and finally analysed with the aid of LabVIEW software. Figure A.20, below, shows a top view drawing of the setup.
